# Dam Rehabilitation Fact Sheet

## Mountain Run Lake, Mountain Run Watershed

**Proposed Solution:**

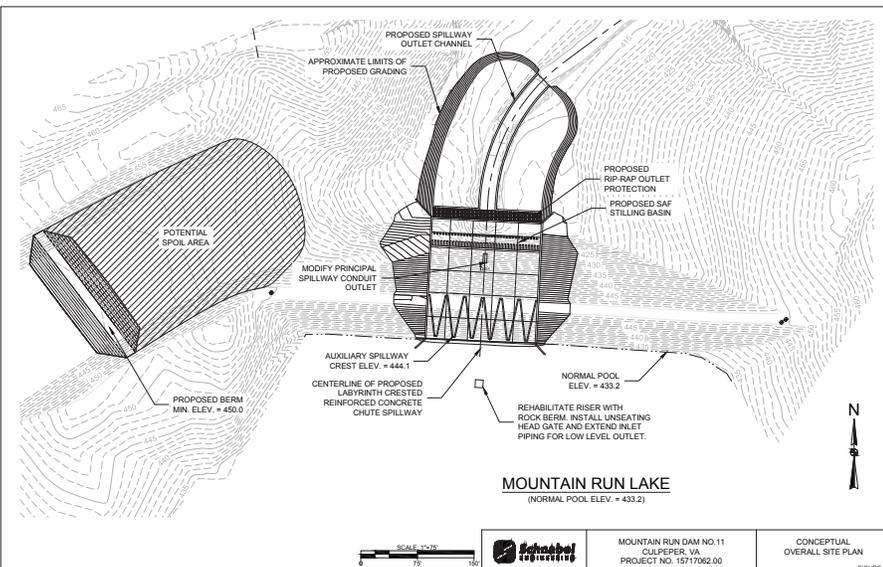
The plan view drawing below outlines the proposed solution to the auxiliary spillway problem.

The plan includes the following rehabilitation activities:

- Installing a 144-foot wide, 6-cycle structural concrete labyrinth weir auxiliary spillway over the embankment
- Installing an earthen berm across the existing auxiliary spillway
- Installing a stilling basin and rip-rap outlet protection below the dam
- Upgrading the principal spillway riser to meet seismic criteria through the installation of about 5.5 feet of granular rock fill placed above and around the periphery of the existing riser footer

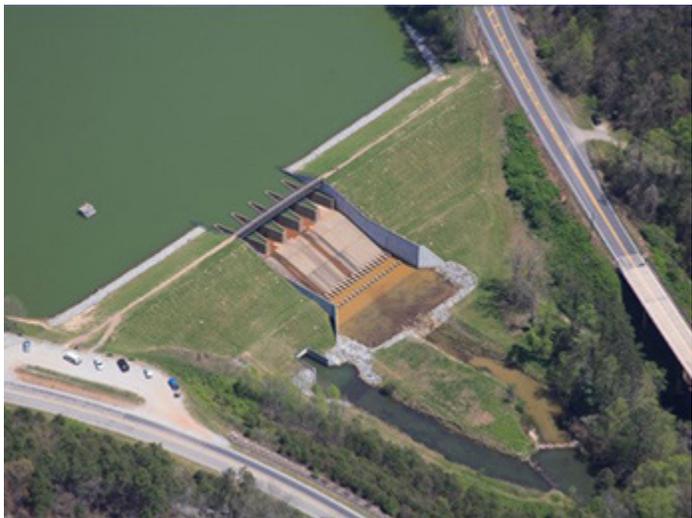
The photo above is an aerial view of a typical labyrinth weir. The graphic below provides a closer look at how this enhancement to a spillway helps to control rising flood waters.
